Stormwater Control Measures Inspection Report Site Inspection Report

Project Name:	Bridlewood, Cottages at Neptune Canyon	Jurisdiction:	Sussex County
Inspected:	Entire Project		
Owner:	Rush Ellis rushellis@aol.com	Inspector:	Buddy Griffith
		Inspection Completed:	08-25-2023 03:41 pm
		Inspection weather:	Temperature: 86 degrees, Partly Cloudy
		Inspection Type:	Annually
		Current Activity:	Not Applicable;
		Current Site Status:	Non-compliant

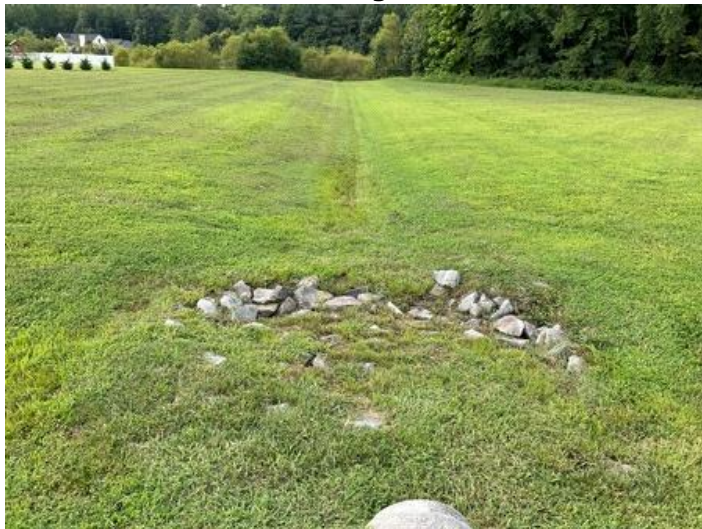
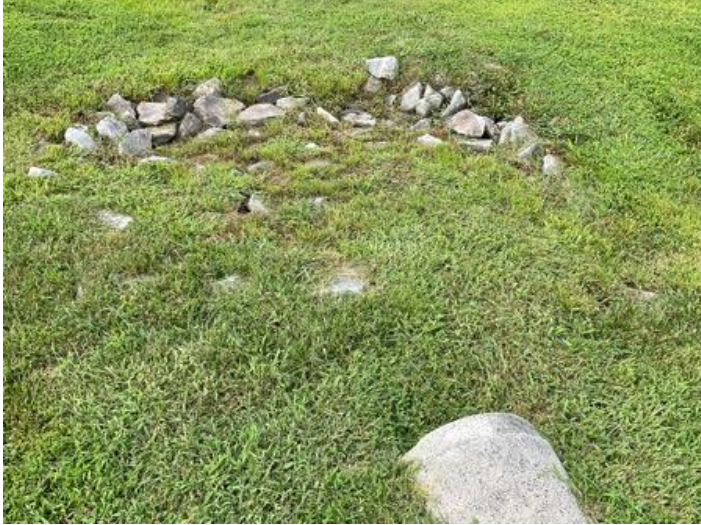
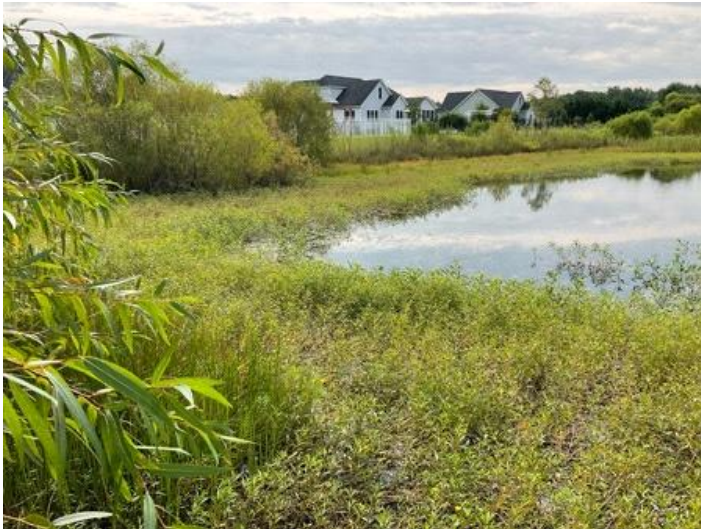
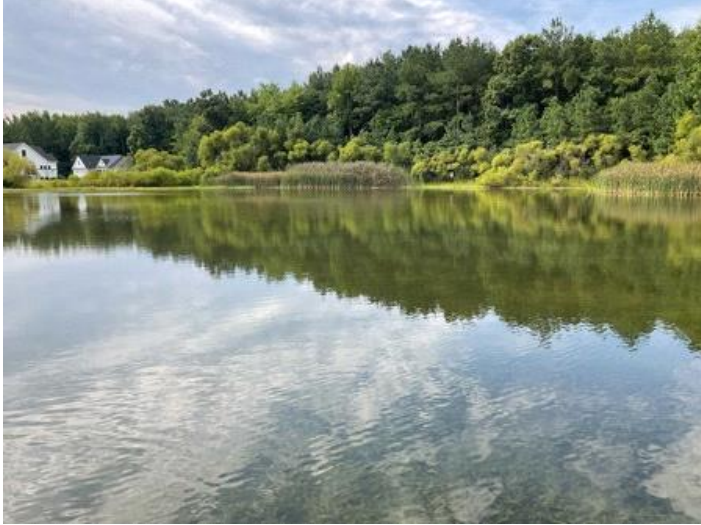
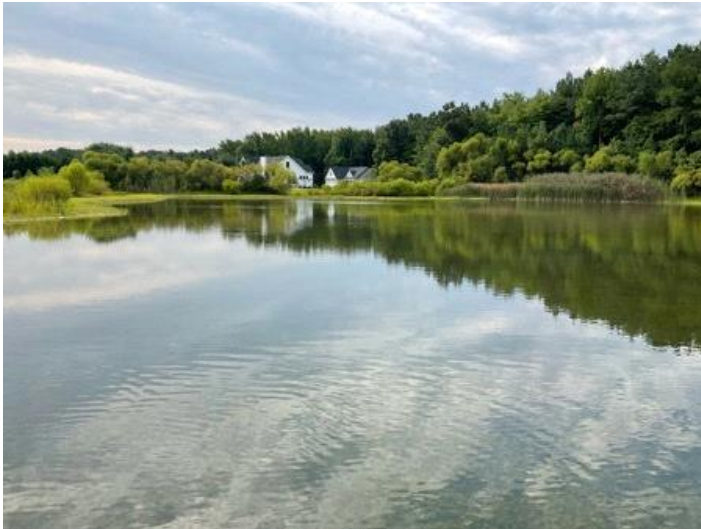
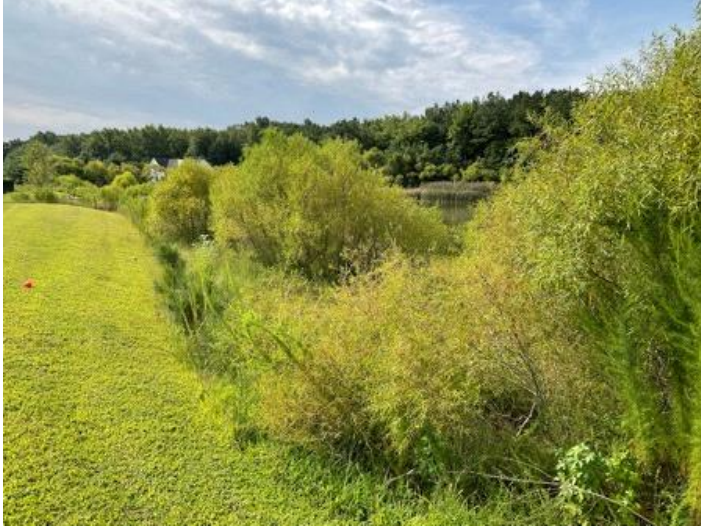
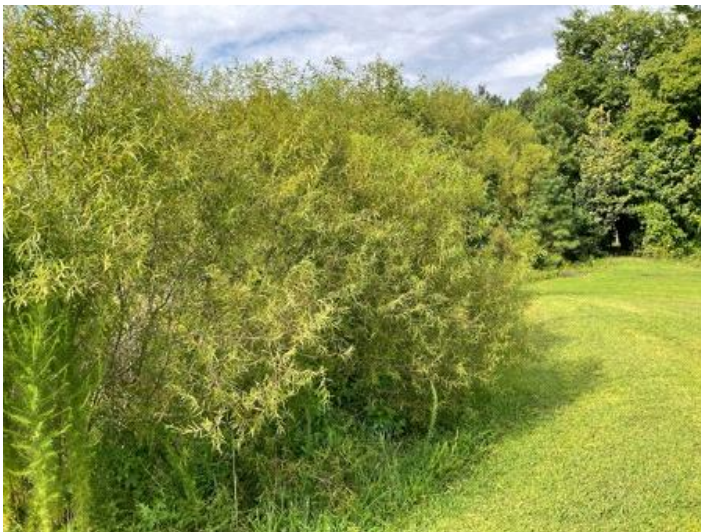
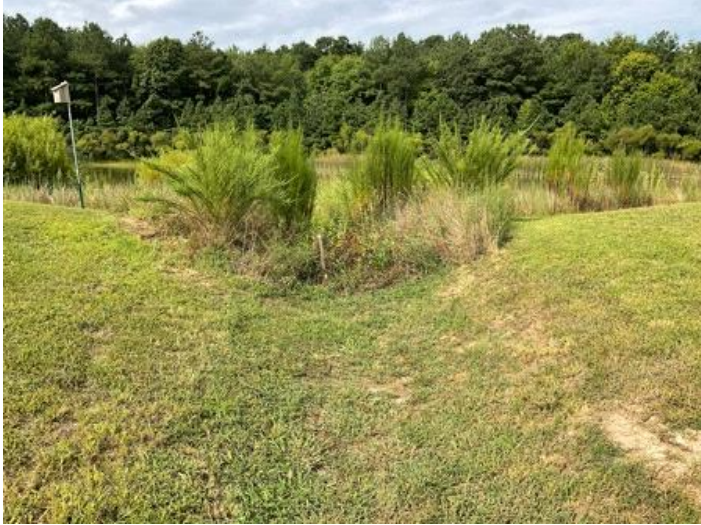
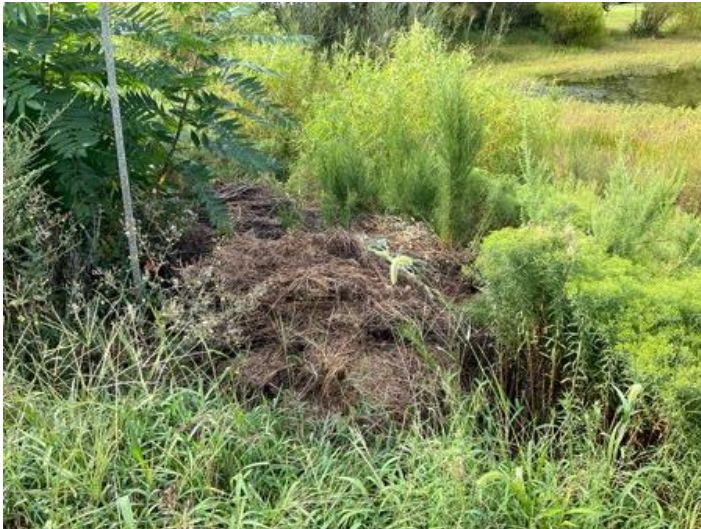
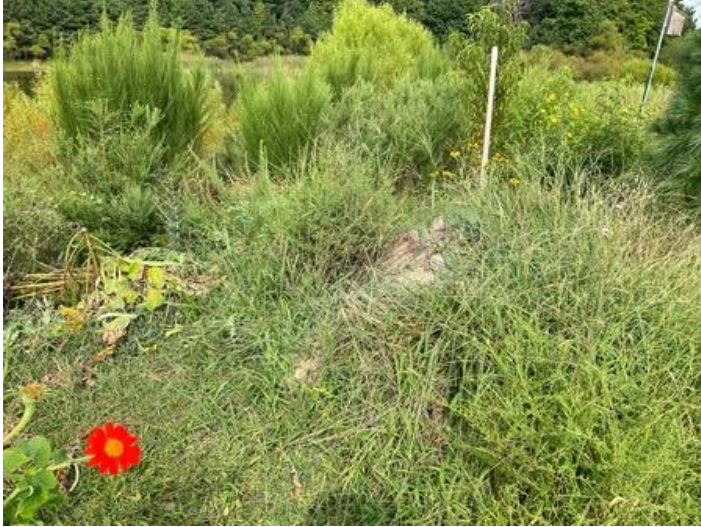
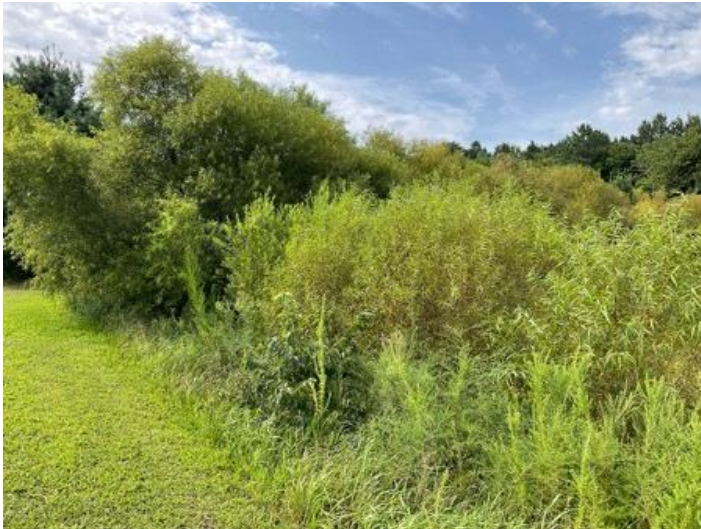
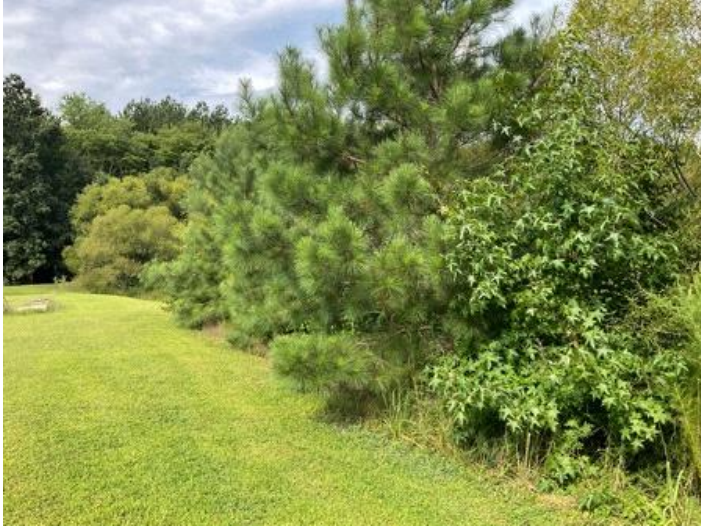
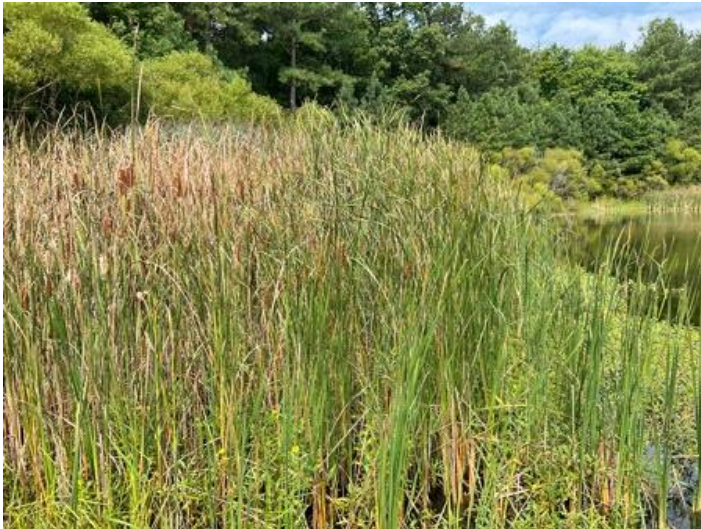
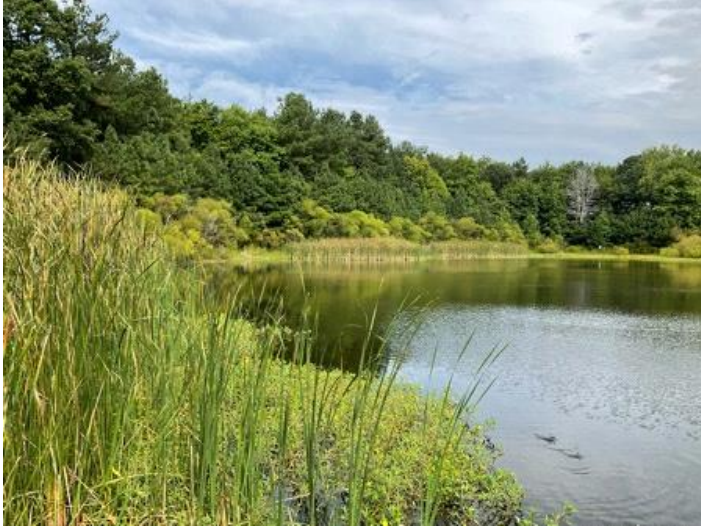
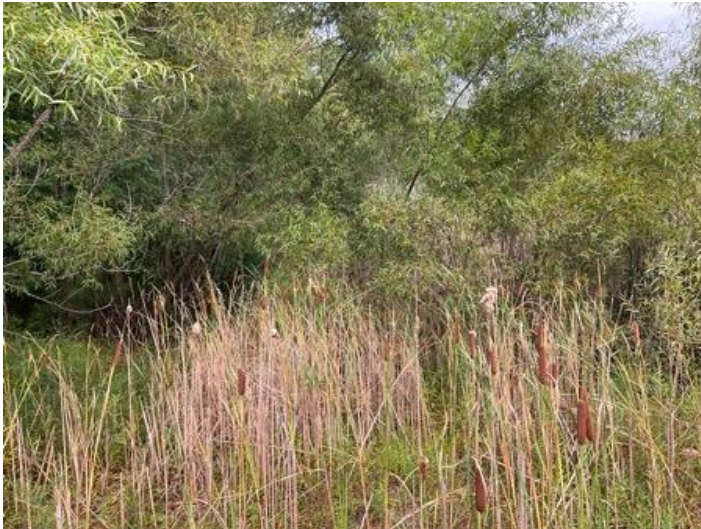
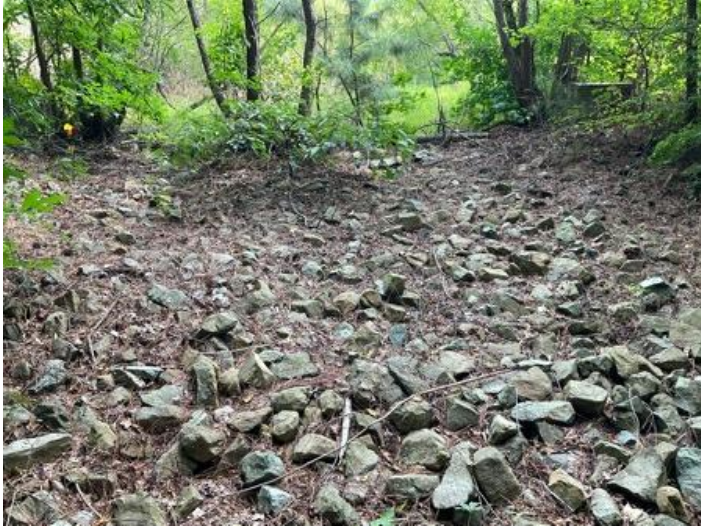
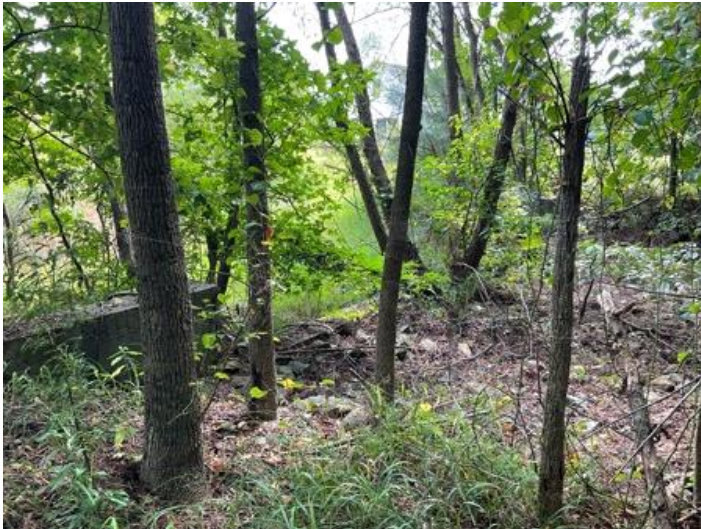
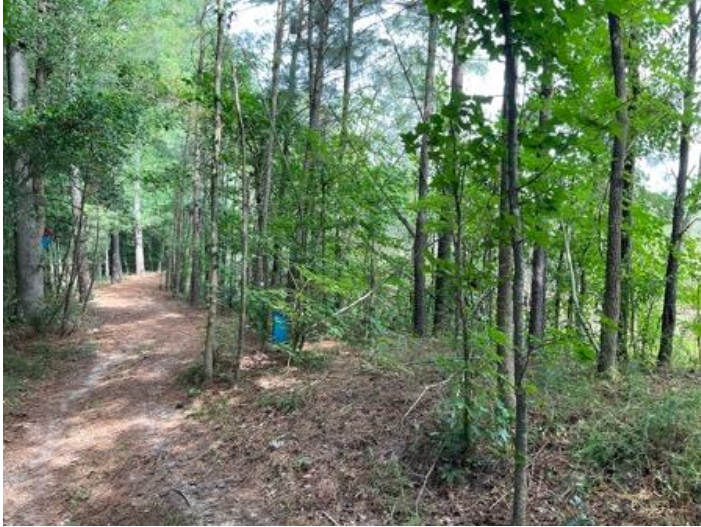
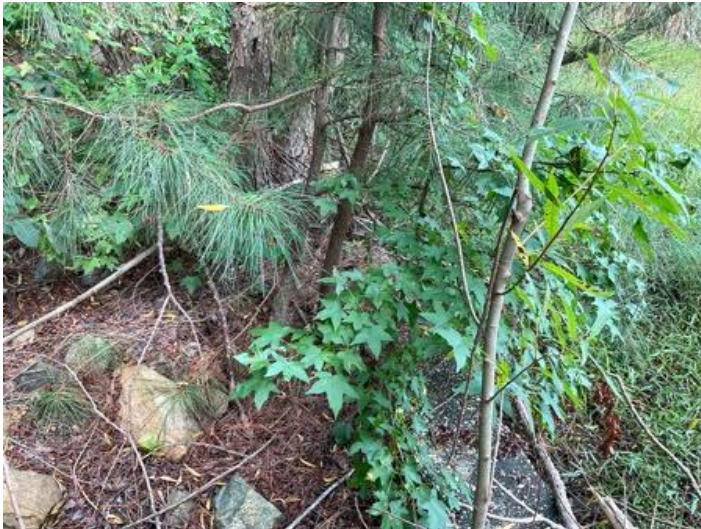
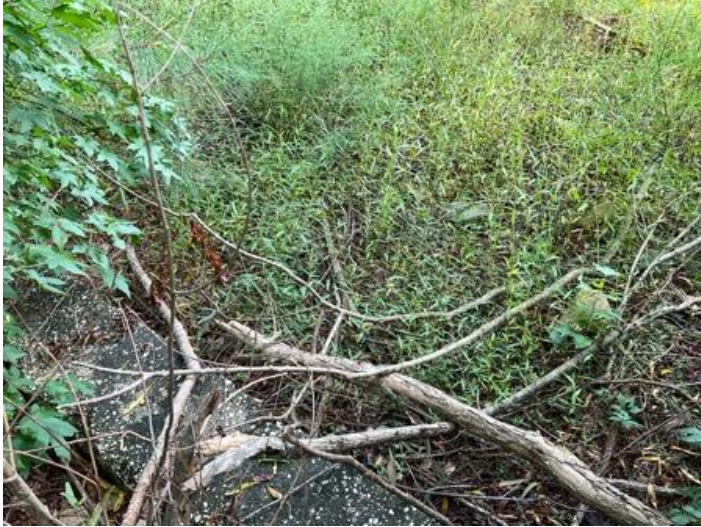
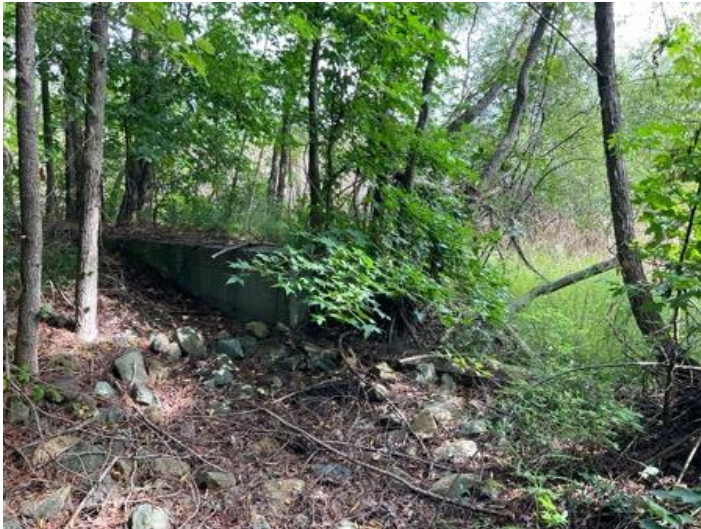
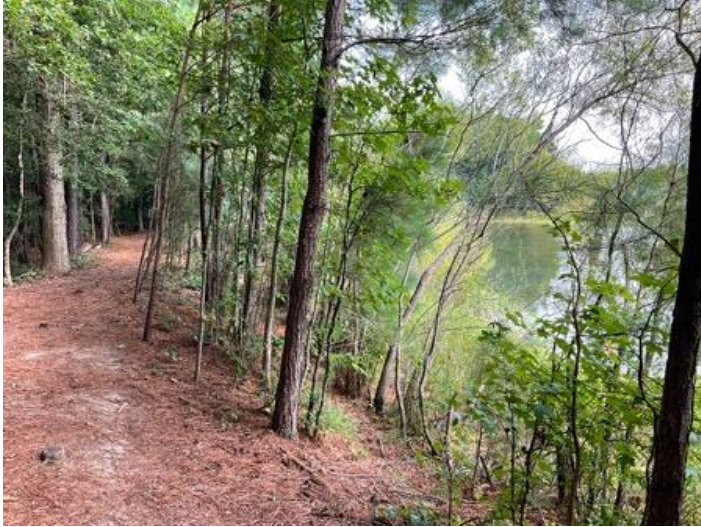
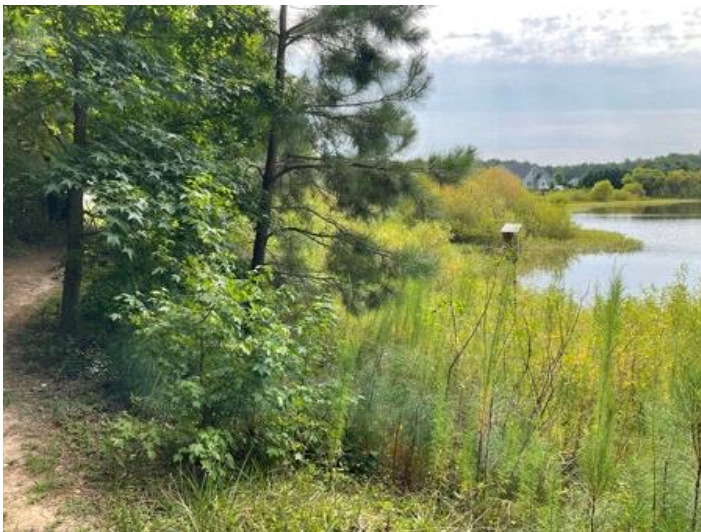
4)	Are relevant components of the BMP (i.e. slopes, buffers, channels, outlets, inlets, forebay, pond bottom) free of evidence of excessive sediment accumulation?	Open Work Items Exist
	Maintenance Action Required- Noted: 08 / 25 / 2023 See notes and photo section for comments on sedimentation in the riprap swale

See notes and photo section for comments on the outlet.

See notes and photo section for comments on unwanted vegetation . | |

See notes and photo section for comments on the embankment | |

This stormwater is not being maintained. Trees, phragmites, dirt piled on the embankment along with the outlet spillway allowed to grow up in trees requires immediate attention. It is Sussex Conservation District's position that no trees are allowed to grow in the basin or on the embankment. The riprap spillway around the weir wall outlet should not have any trees or tree debris that will damage the weir wall with root growth or potentially block the release of stormwater. The riprap in the inlet swales should be periodically cleaned of sedimentation which will eventually fail to filter stormwater as designed. These comments are recommendations only as once a subdivision has been released as this one has SCD has no authority to mandate that the work be performed. My job is to make assessment and recommendations to return the stormwater facility to its original design so that it continues to function as designed.
